Shift to "Anti-collapsed Levee

Large-scale flood damage occurs every year in various places due to global climate change. The biggest factor behind the serious damage is the collapse of an embankment. A typical river levee is a "soil embankment" that only fills the soil, and it contains scientific factors that cannot withstand the increase of water in the river and overflow. The "Implant Lock Levee" is designed to strengthen a resilient levee

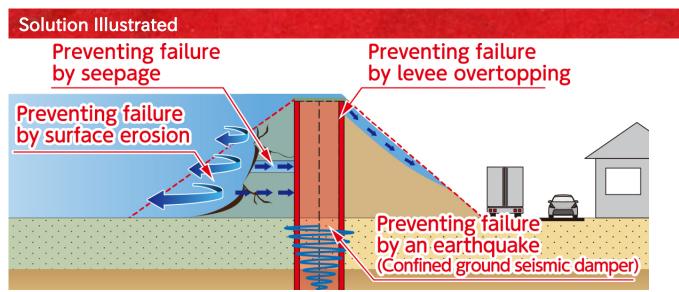
by constructing double rows of continuous walls with Implant Structure and a partition within this "soil embankment."

The Implant Lock Levee remains functional as a levee even if the embankment is eroded due to flood overtopping or seeping. In addition, in the event of an earthquake, the ground surrounded by double steel sheet pile walls with partition walls can be restrained by so called "confined ground seismic damper" in order to restrain the flow of liquefied ground and ground subsidence. The main feature of this embankment is its structure which aims not only to overflow and seep but also to prevent from breaking down in the event of a major earthquake.

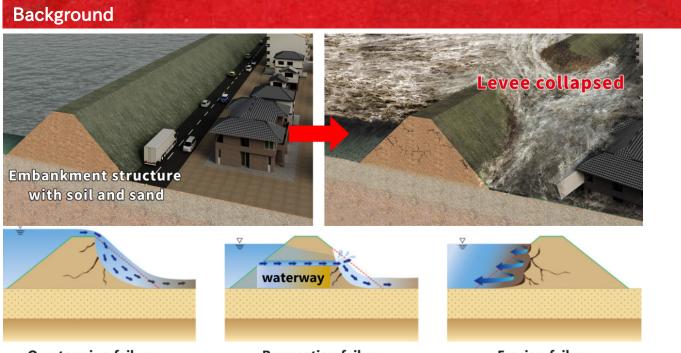
Overtopping failure

Permeation failure

Erosion failure

Most of the river levees are built of soil, which is being raised and widened after flood damage. When planning and designing, there are numerous factors to consider, such as the complex distribution of soil quality and strength, the potential for differential settlement, the need for long-term maintenance, and the close relationship with the livelihoods and natural environment of the watershed, which plays a crucial role in the landscape. Therefore, comprehensive disaster countermeasures, including earthquake and tsunami countermeasures are desired, with a focus on realizing resilient performance

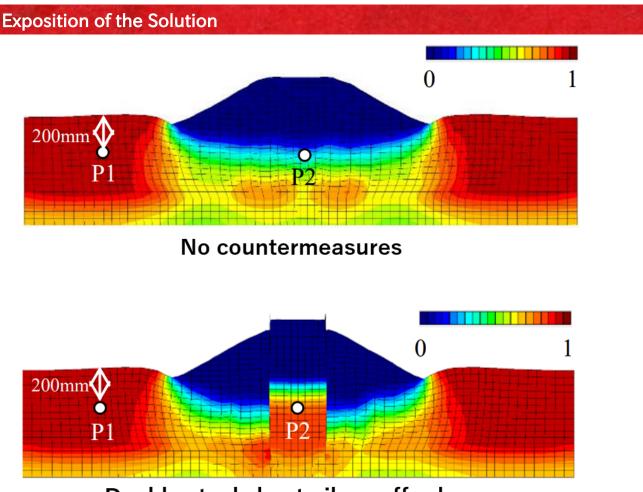
Double steel sheet piles cofferdam

Sourse: "Japanese Geotechnical Journal"Vol.12, No.1, 109-122, P.117, Figure 13

The seismic performance of embankments reinforced by this method has been verified for coastal embankments and river embankments.

Even in the situation where the side of the levee body collapses due to an earthquake accompanied by liquefaction, it has been clarified that double steel sheet pile walls and tie rod materials restrain the deformation of the core part and that the top height is maintained by the steel sheet pile walls placed in the supporting ground.

This earthquake-resistant mechanism is reproduced by a FEM (finite element method) that can consider liquefaction and build an earthquake-resistant design method for level 2 earthquake ground motion The following points are demonstrated as features of this method.

• During flooding, the steel sheet pile wall is properly embedded to control boiling, and even if overflow occurs, the crest height can be maintained and the amount of overflow can be limited.

•In an earthquake, the deformation of the core part is suppressed by the restraint effect of double steel sheet piles joined by tie rod materials, and it is possible to reduce the liquefaction damage.

•Even for complex disasters in which tsunami strikes immediately after an earthquake, the amount of overtopping water by the tsunami can be limited because the crest height during the earthquake is maintained by placing the lower end of the steel sheet pile on a strong ground.

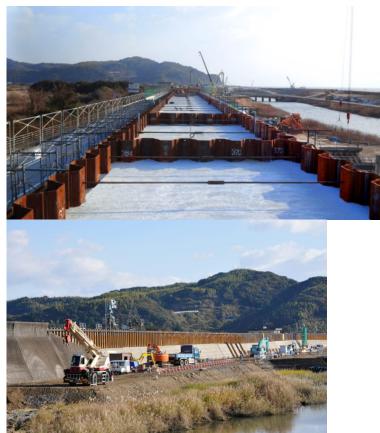
Kochi coastal levee improvement construction at the Nino section (Kochi City, Kochi Prefecture)/ Kochi River National Road Office of Shikoku Regional Development Bureau, Ministry of Land, Infrastructure and Transport

Implant Lock Levee has been adopted in some sections of the Kochi coastal embankment improvement work.

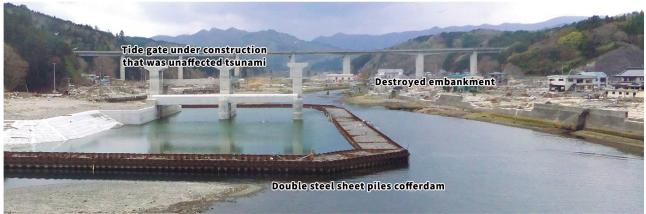
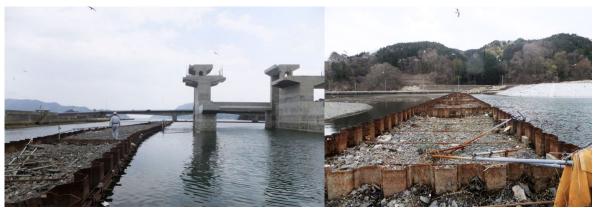
Orikasa, Yamadamachi, Shimohei-gun, Iwate Prefecture

At the time of the Great East Japan Earthquake, a similar structure was adopted as a temporary cofferdam structure for the construction of a tide gate near the river mouth of the Iwakasa River in Iwate Prefecture. While the surrounding river embankments and the residential area were destroyed, double steel sheet pile walls and the floodgates built inside the cofferdam were almost free from the tsunami damage, demonstrating their high earthquake resistance and tsunami resistance.
