NIPPON STEEL METAL PRODUCTS CO.,LTD.

## Landslide / Slope Failure Prevention Method

Landslide / Slope Failure Prevention Method which enables to preserve or recover vegetation

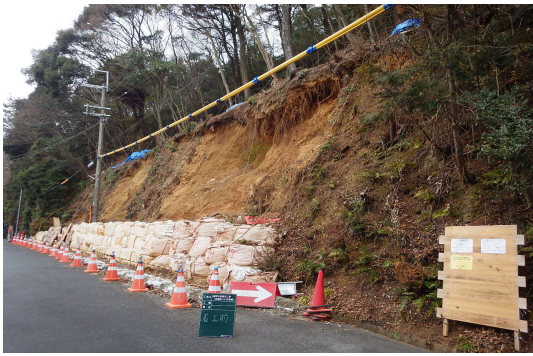
Right after slope failure

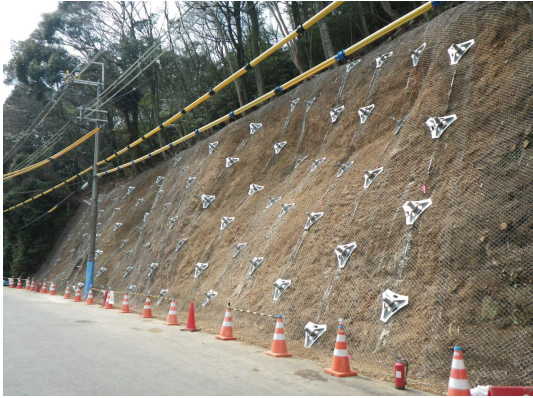
Right after construction of NONFRAME® method

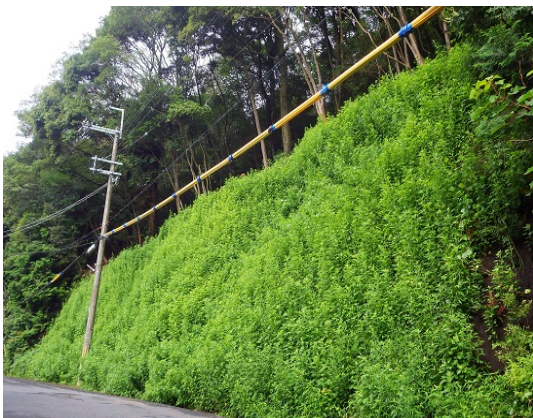
4 months after construction, the slope had been fully covered

with vegetation

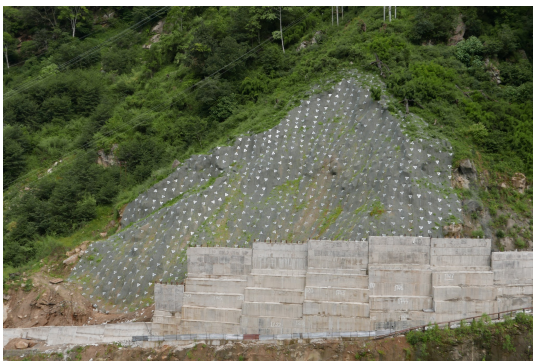
Construction example in Bhutan

This is the project with regard to Hydroelectric Project dam site in Trongsa, Bhutan. In 2015, the slope failed due to torrential rainfall and five workers were killed, even though it was originally covered with shotcrete. Then, NONFRAME® method was installed on the corrupted slope to stabilize the slope. The construction area was total 5,400 sqm, however the construction finished only three months even

severe condition, because NONFRAME® method is easy to construction even unskilled worker.  
After construction, the slope has been stabilized by this method and has been covered with vegetation.
